Inspection Report

Property Address:
123-45 State Street
Flushing, NY 11363

PRIVATE EYE HOME INSPECTION SERVICES, INC.

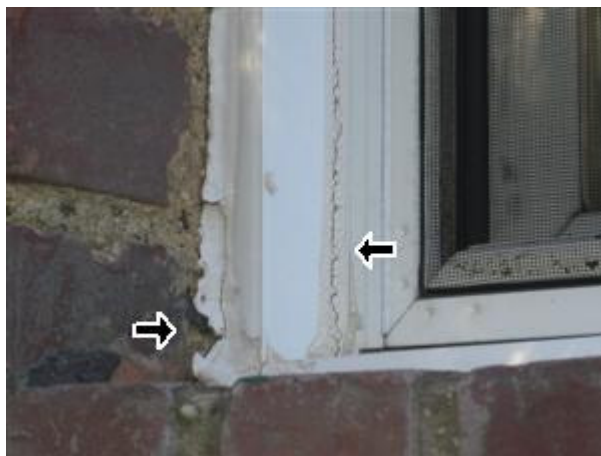
1.1 Picture 1

There are security bars on most windows.

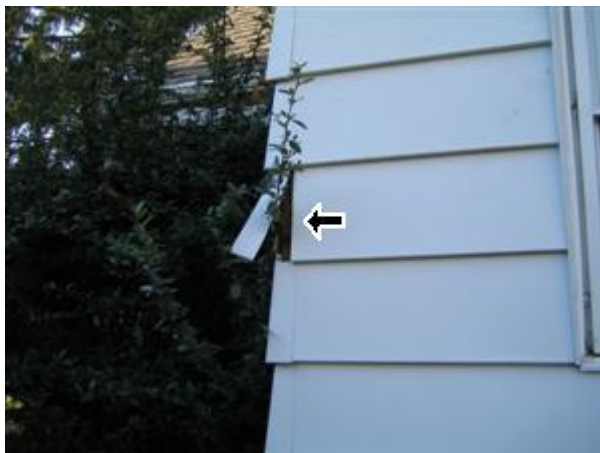
1.2 Picture 1

Comments:
 Rear corners of the back aluminum siding need repair. see photo.

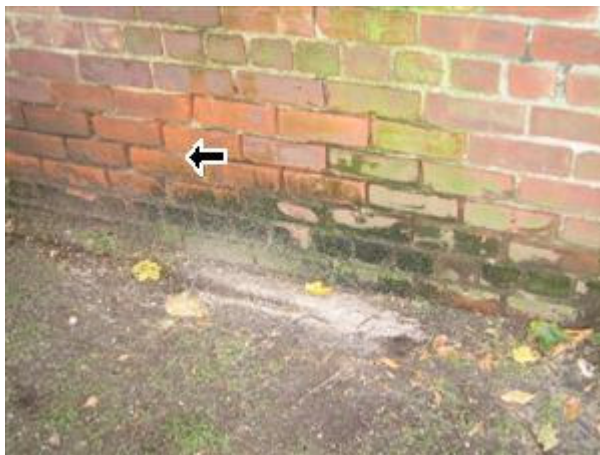
1.2 Picture 2

The entire house needs Brick Pointing. see photo

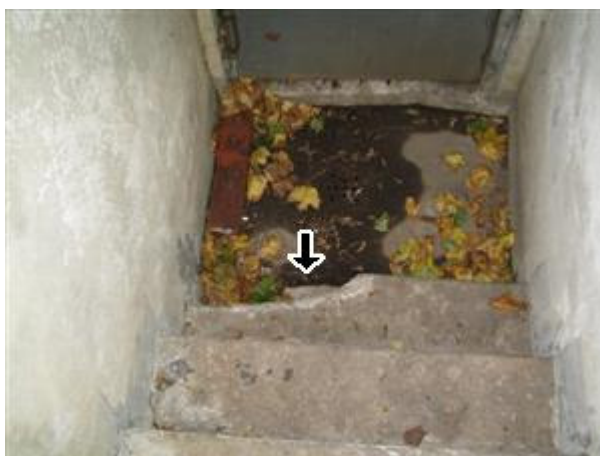
1.3 Picture 1

Basement step is broken and missing concrete. see photo.

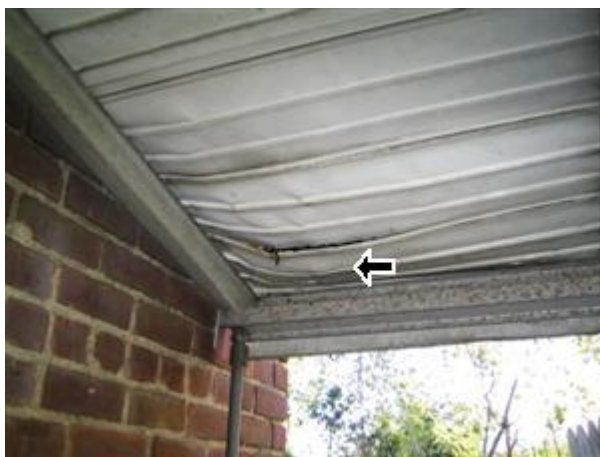
1.3 Picture 2

Damaged aluminum roof over basement steps. see photo.

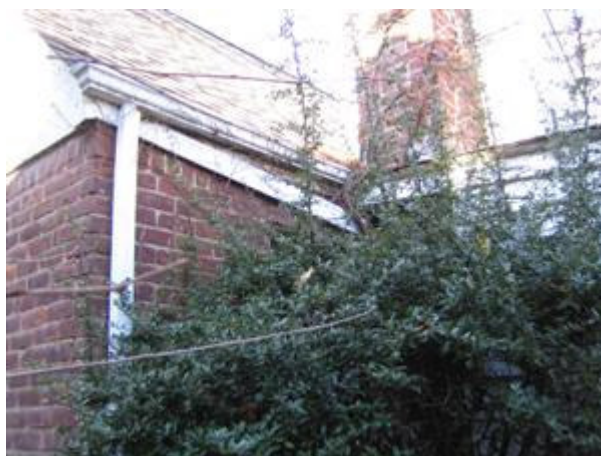
1.4 Picture 1

Rear vegetation against house is growing into rear window and along chimney. The vegetation is eating away the mortar and is possibly weakening the integrity of the chimney. The chimney needs pointing. Consult a masonry contractor. see photo

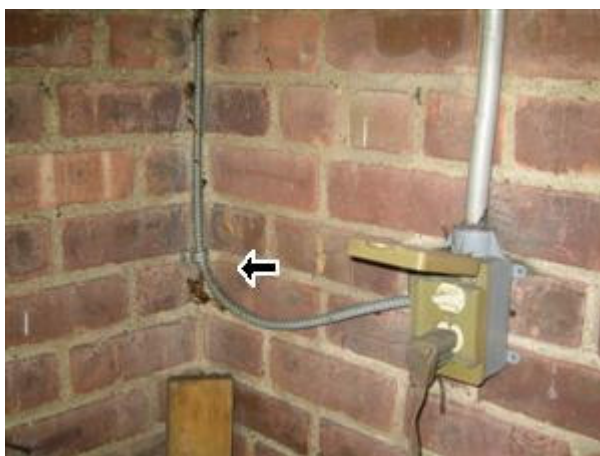
1.9 Picture 1

Exposed BX is feeding cluster light on rear peak from switch at basement steps. Consult a licensed electrician for removal and reinstallation of conduit. see photo.

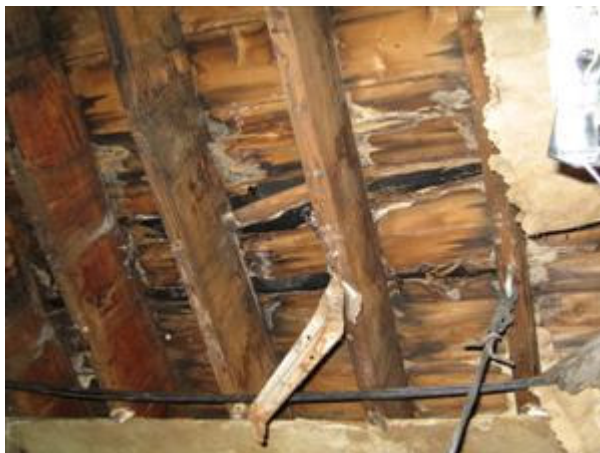
3.0 Picture 1

The roof over the garage has water pooling with rotted planking and should be checked by a Qualified Roofing Contractor. Sheetrock was also damaged and missing. see photo.

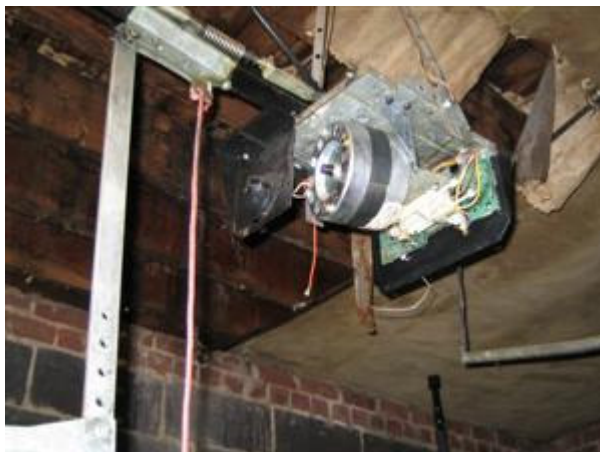
- 3.1 GARAGE WALLS (INCLUDING FIREWALL SEPARATION)
Garage Wall Structure: Wood, Masonry, 2 X 4 Wood, Sheetrock
Garage Insulation: None
Comments:
 There is an interior wall in the garage which is part of the living room.
- 3.2 GARAGE FLOOR
Garage Floor: Poured Concrete
Comments:
- 3.3 GARAGE DOOR (S)
Garage Door Type: One automatic
Garage Door Material: Fiberglass
Garage Trim: Wood
Comments:
- 3.4 OCCUPANT DOOR FROM GARAGE TO OUTSIDE
Comments:
- 3.5 OCCUPANT DOOR FROM GARAGE TO INSIDE HOME
Comments:
- 3.6 GARAGE DOOR OPERATORS (Report whether or not doors will auto reverse when met with resistance)
Garage Door Opener: UNKNOWN
Comments:
 Garage door opening unit was not connected and looks like it needs to be repaired or replaced. see photo.

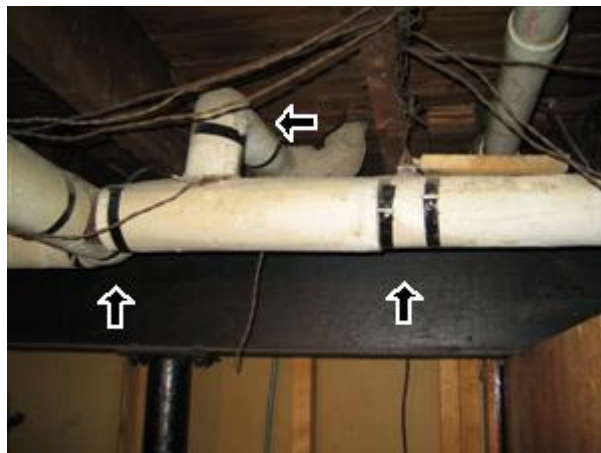
11.7 Picture 1

The piping in the basement leading from the boiler has what looks like the original insulation and should be checked for Asbestos by a qualified environmental inspector. see photo.

The returning condensate line to the boiler from the radiators that is around the floor perimeter is extremely rusted and looks like it could leak at any time. This should be repaired as soon as possible. I recommend a licensed plumbing contractor.
